R&R the Radius Ball

Bill Lee
January 2012

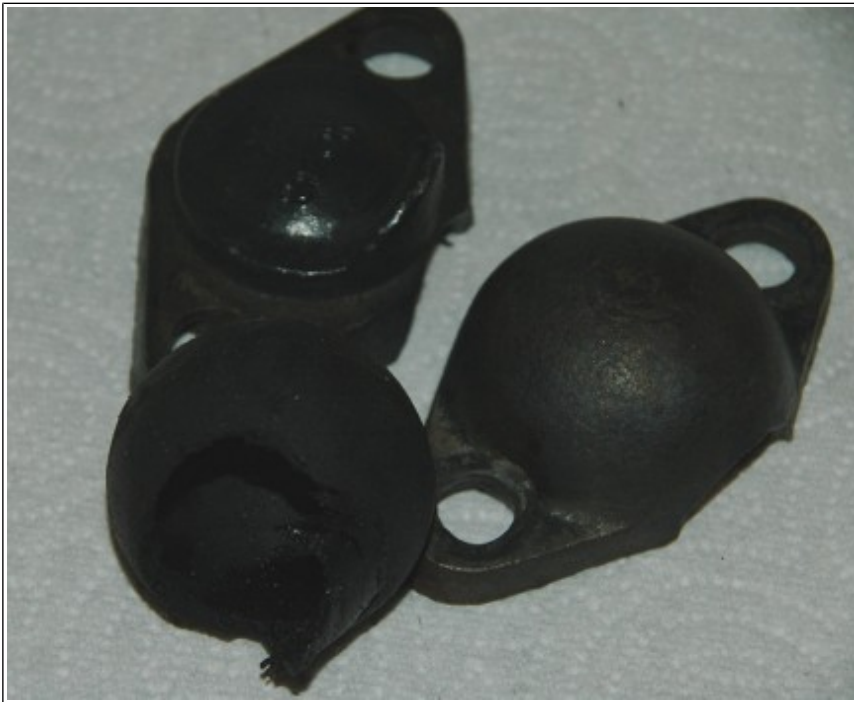
Taking off the nuts on the radius ball cap, I discovered several things. First, there were no cotter pins, no spacers, no springs, and the caps were cast iron. Inside the caps, the ball was encased in a rubber ball.

As you can see the rubber ball was seriously deteriorated.

The original restoration of my car was done about 25 year ago, and the car has just over 4,000 miles on it since then. I suspect that time and continuous oil soak caused the rubber to deteriorate, although the major area of damage is at the bottom of the radius ball.

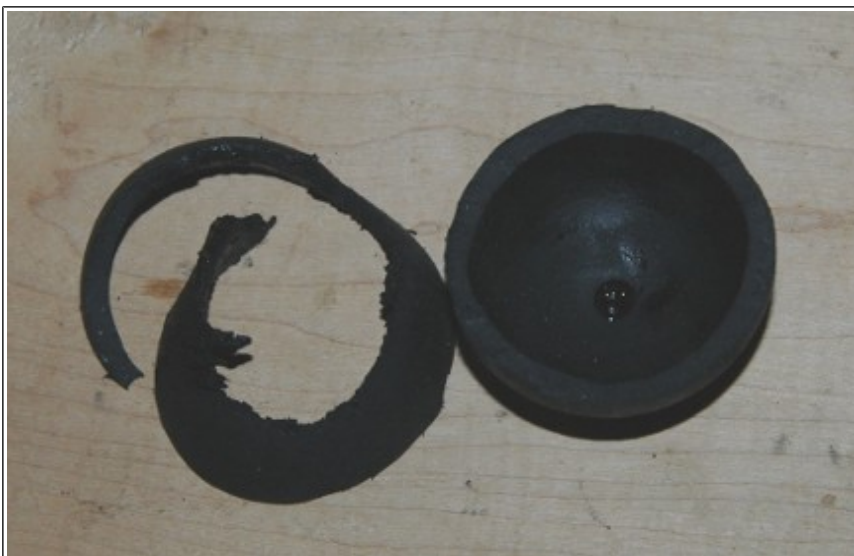
I did a bit of analysis of the rubber ball and the cast iron caps. I cut the ball around the circumference at the mold line that was still visible on the ball. Looking at the pieces, you can see that the ball is noticeably thinned on the left side in the picture, and that corresponds to the totally disintegrated area that was the front half of the ball. In the picture, the area of the rubber that was on the bottom of the radius ball is at the left of each piece.

The rubber thickness measured on the top of the rubber ball was about .150" while on the side where it had worn, it was only about .110". The rubber thickness was measured after cutting the rubber ball in half (see the second picture).

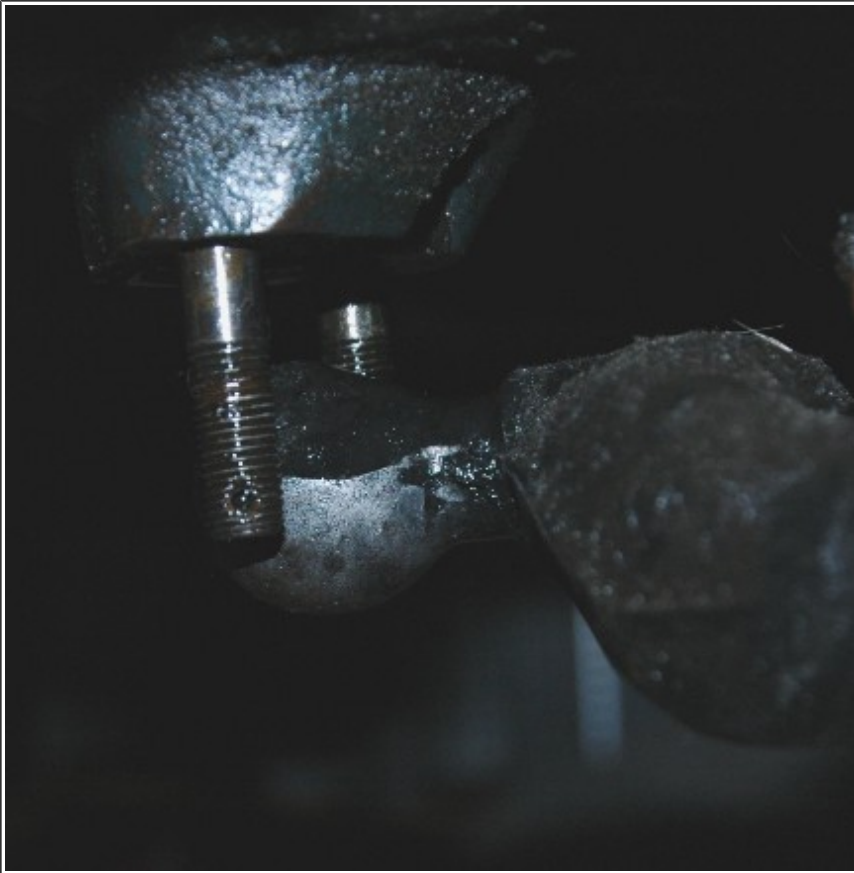
Examining the radius ball itself, I found that the ball looked worn on the bottom half. I think the ball was painted totally black when the restoration was done. You can see in the picture that the bottom half of the ball is now bare metal. All signs of "blackness" is gone there, but still is apparent on the top half.

I used a dial caliper and measured the ball as best I could. The ball is supposed to be 1-1/2" diameter. The ball on my car was worn some. It is about .050" small side-to-side (1.450") and about .090" small top-to-bottom (1.410").

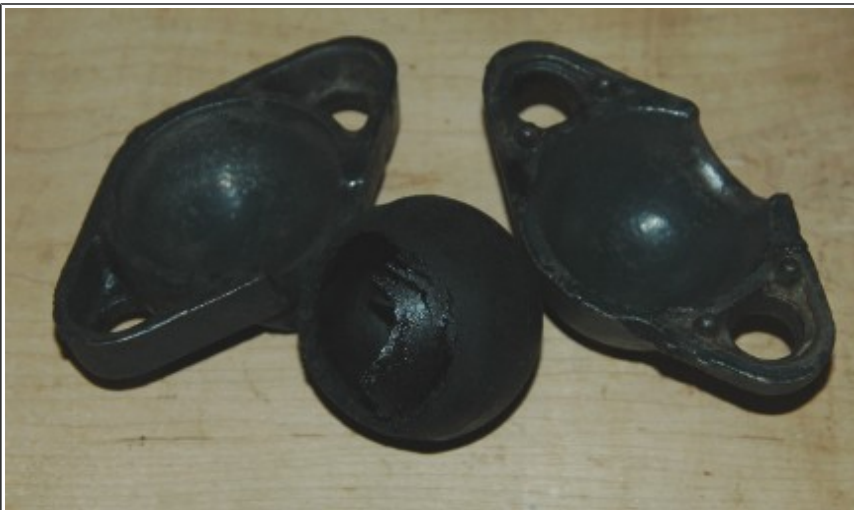
I then measured the various dimensions on the cast iron cups and the rubber ball.

The inside diameter of the cast iron cup cavity is 1.850". This dimension was measured at the opening of each piece as well as by measuring the depth of each piece and adding.

Adding some numbers: the normal diameter of the radius ball is 1.500". The rubber ball wall thickness is .150" or .300" total. When the rubber ball is surrounding the radius ball, the sum of these dimensions is 1.800". As you can see the rubber encased radius ball is NOT a snug fit within the cavity of the cast iron caps, and this is only exacerbated by the wear apparent on the radius ball on my car.

I think I can safely point at this as the source of the suspension banging I had started to encounter: too much "slop" in the radius ball mount.

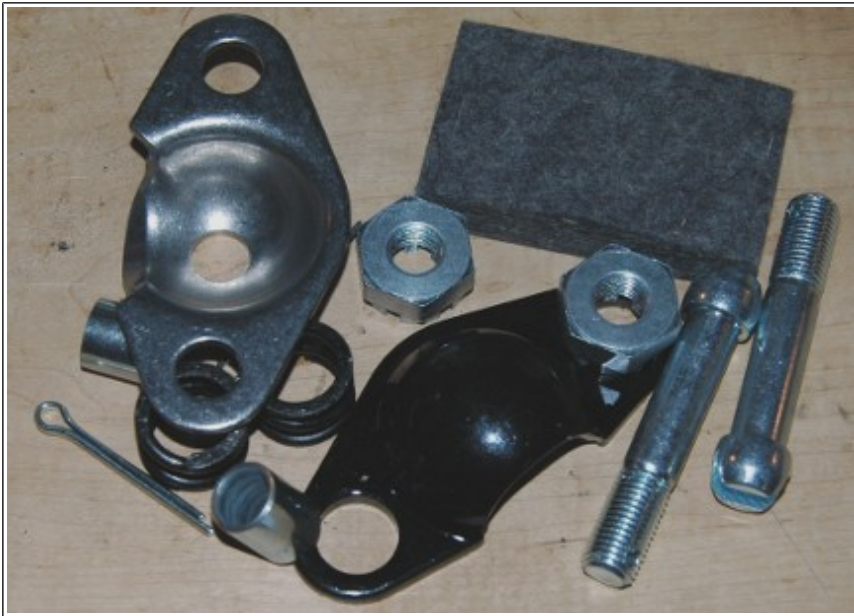
A call to Piranio's and Beth sent me the radius ball kit (part #A-3440-A, aka at Snyder's as A-3440-S) The felt isn't part of the kit, I ordered it separately.

I had already obtained the cupped washer.

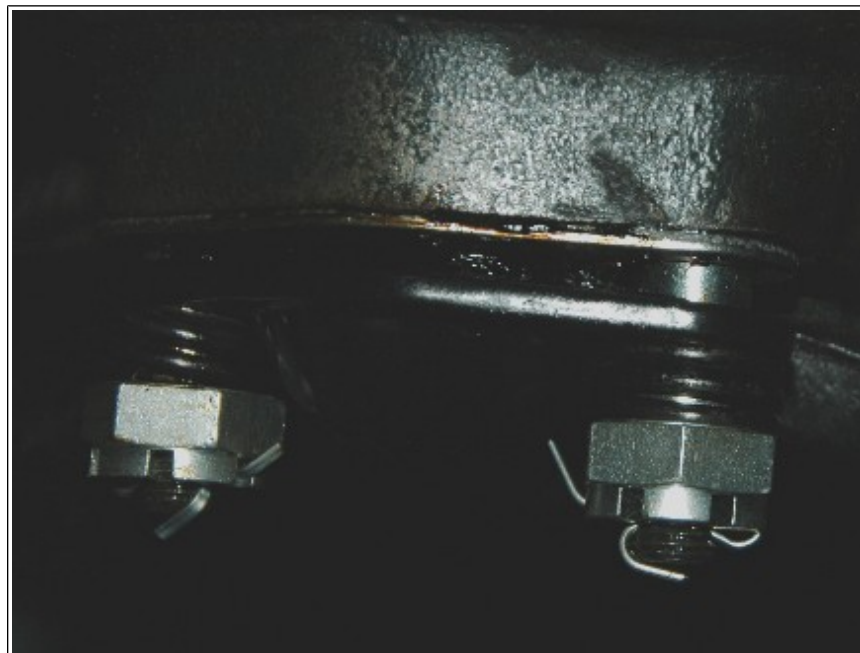
Assembly was really a trivial exercise. I dragged a floor jack under the car and used a piece of wood as a spacer. The jack was just an easy way to hold the radius ball and wishbone up tight to the bottom of the fly wheel housing while I was assembling all of the pieces.

I first put it all together without the cupped washer, but the two caps were very close to touching when fully tightened, due I presume to the wear on my radius ball. So I took it apart and added the cupped washer. A very liberal dose of grease during assembly was all it took. I had to use some smaller 3/32" cotter pins instead of the 1/8" pins that were in the kit since the holes in the bolts were too small for the 1/8" pins.
